POST EARTHQUAKE INVESTIGATION FIELD MANUAL FOR THE STATE OF KENTUCKY

UNIVERSITY OF KENTUCKY
College of Engineering

Research Report
KTC-06-30/SPR234-01-1F

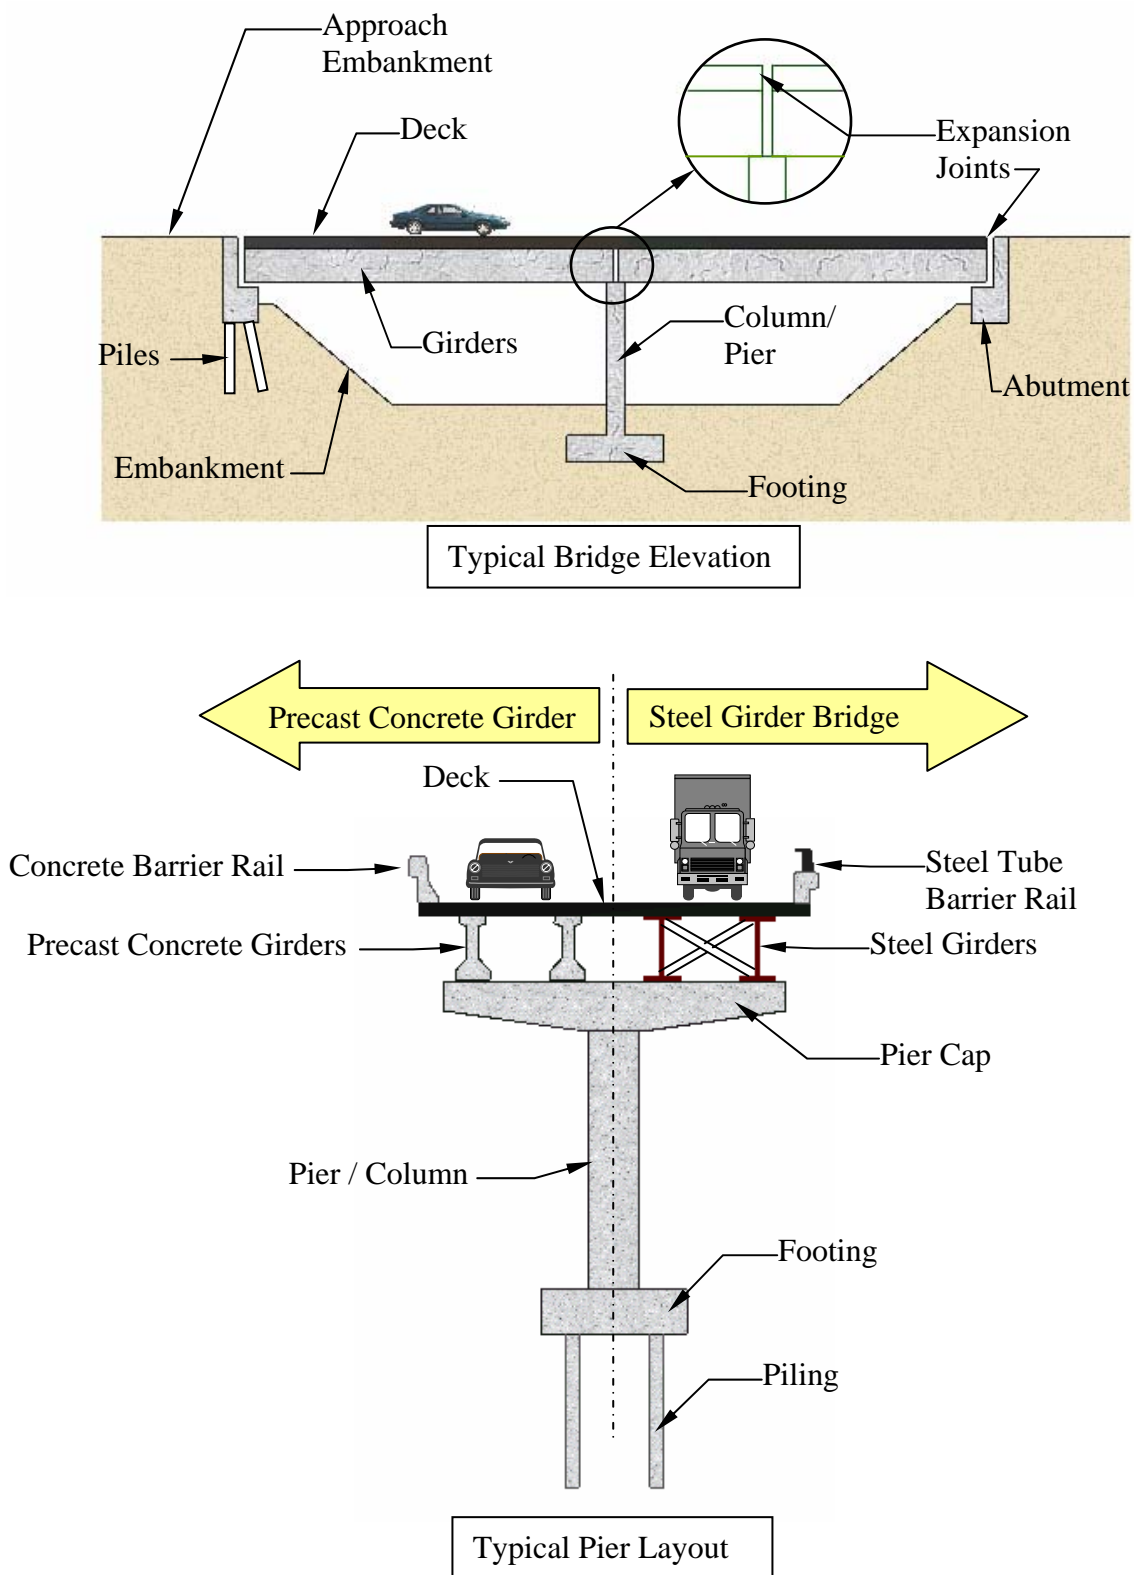
Figure 1 Structural components of a typical highway bridge structure

Highway bridges are composed of various structural components. They include the embankment, main spans, deck, abutments, bearings, and piers or columns. No two bridges are alike and some may not contain all of these components. Figures 1 and 2 show the key components of a typical bridge structure. The substructure portion of a bridge consists of the embankments, abutments, bearings, piers or columns, and foundation system. The supporting elements of the substructure (i.e. the piers or columns) may be a single pier, as shown in Figure 1, or have multiple columns within one or more piers. The superstructure portion consists of the main spans (girders) and deck. The main span of a bridge structure varies depending of the material components. It may be composed of concrete, timber, or steel elements. The main spans include the girder elements and truss members (including cross bracing and/or diagonals).

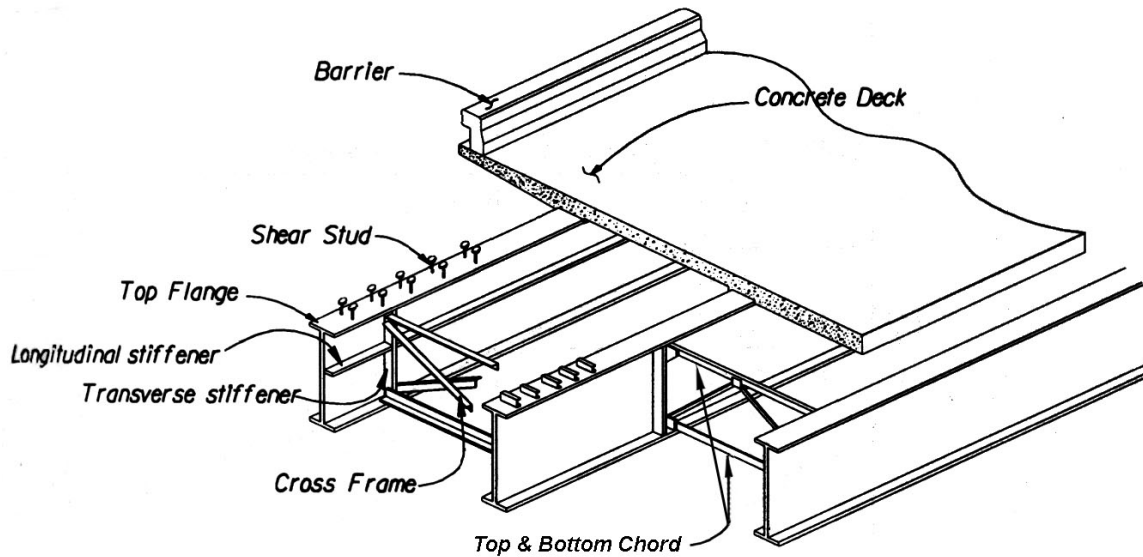
Figure 2 Typical components of a welded steel plate girder bridge (30)

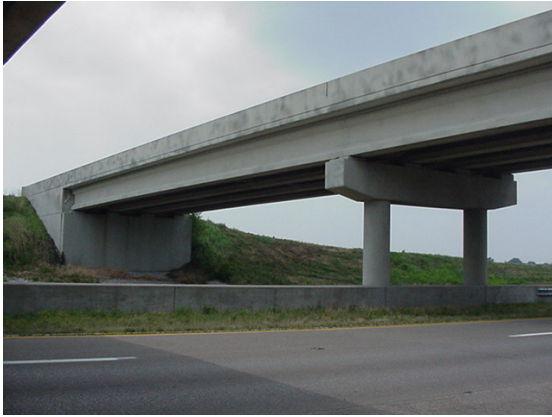
Figure 3
Continuous Precast I-Girder Bridge (25)

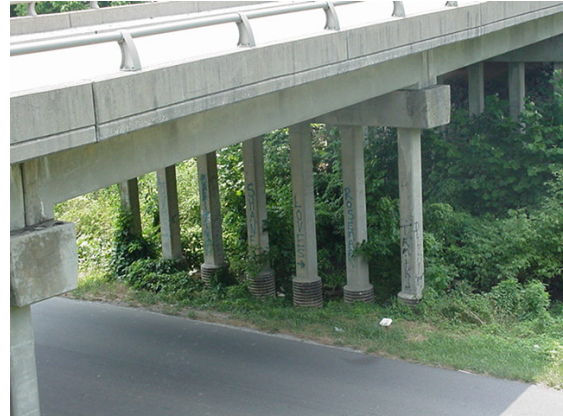
Figure 4
Precast I-Girder Bridge (25)

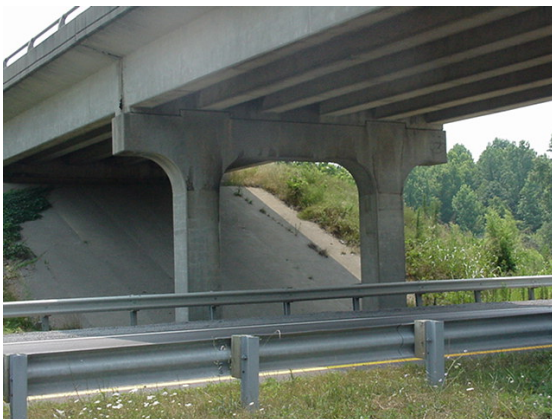
Figure 5
Precast I-Girder Bridge (25)

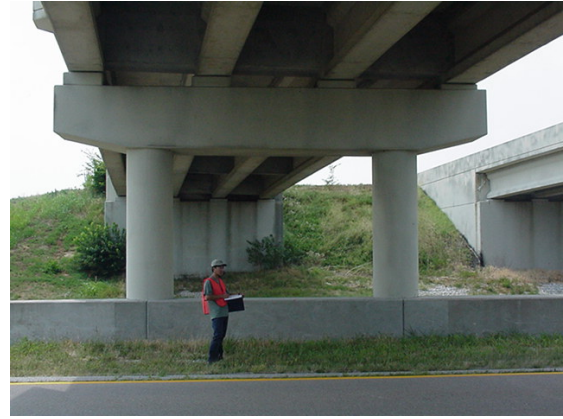
Figure 6
Precast I-Girder Bridge (25)

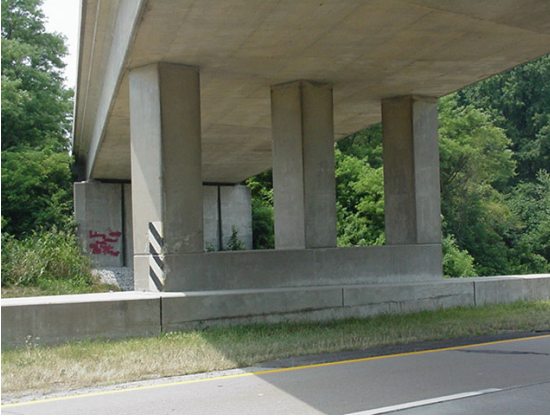
Figure 7
Cast-in-Place Box Girder Bridge (25)

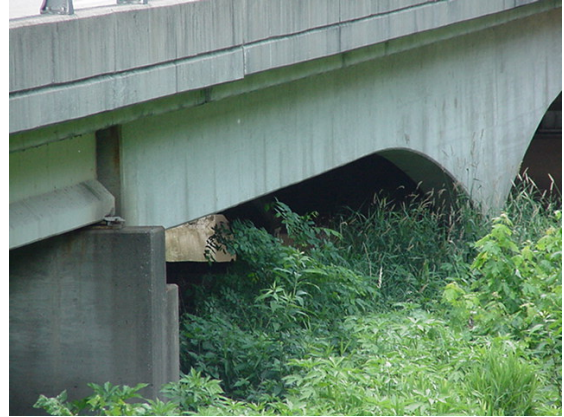
Figure 8
"Haunched" Concrete Girder Bridge (25)

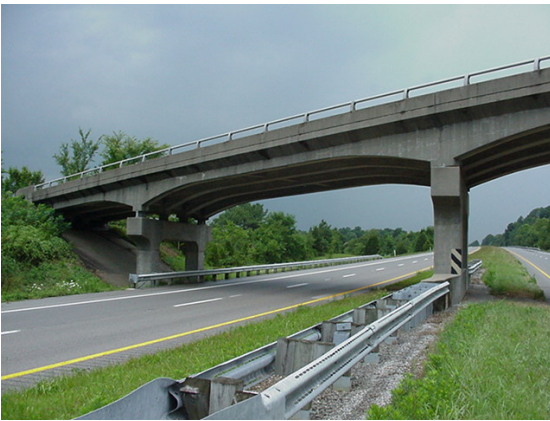
Figure 9
"Haunched" Concrete Girder Bridge (25)

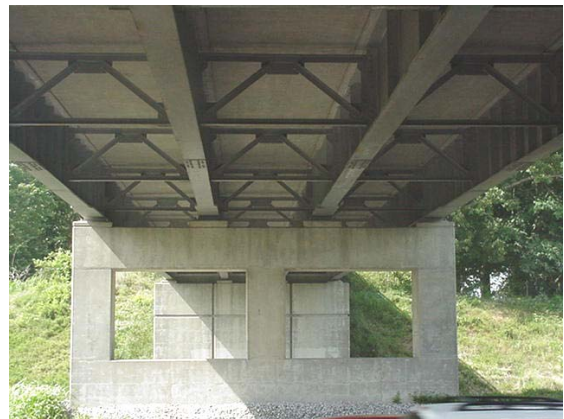
Figure 10
Welded Plate Girder Bridge (25)

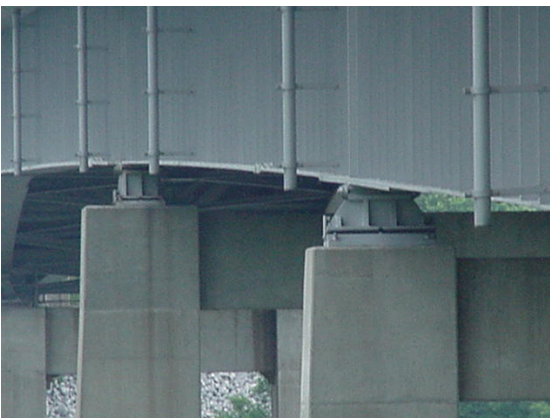
Figure 11
Continuous Welded Plate Girder Bridge (25)

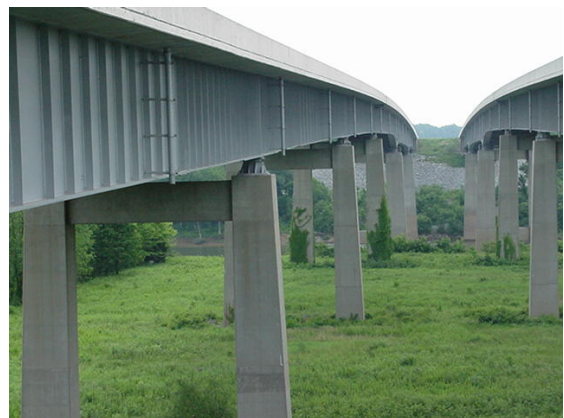
Figure 12
Continuous Welded Plate Girder Bridge (25)

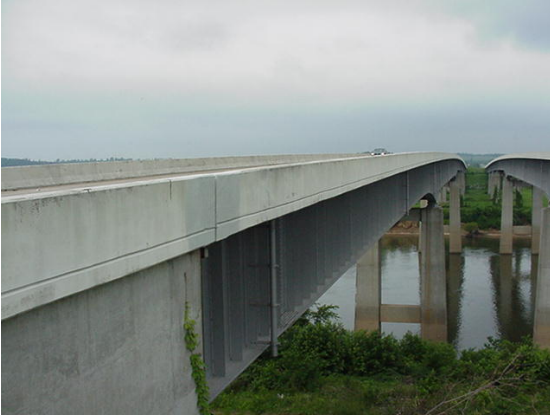
Figure 13
Welded Plate Girder Bridge (25)

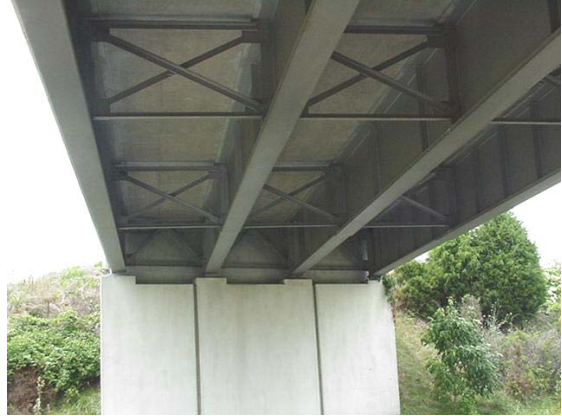
Figure 14
Welded Plate Girder Bridge (25)

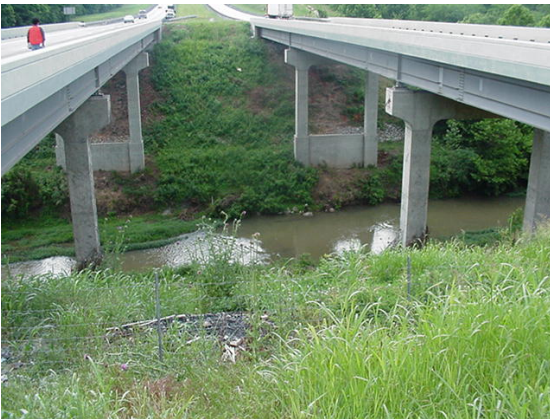
Figure 15
Welded Plate Girder Bridge (25)

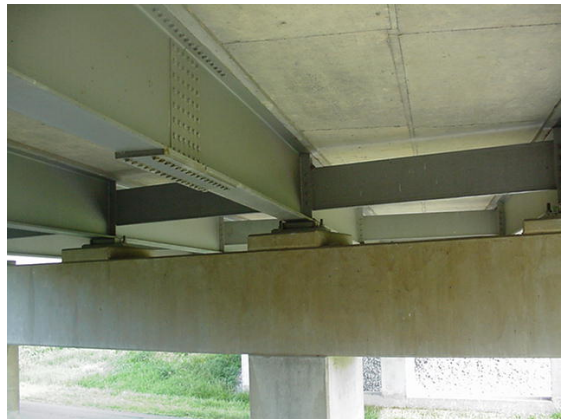
Figure 16
Welded Plate Girder Bridge (25)

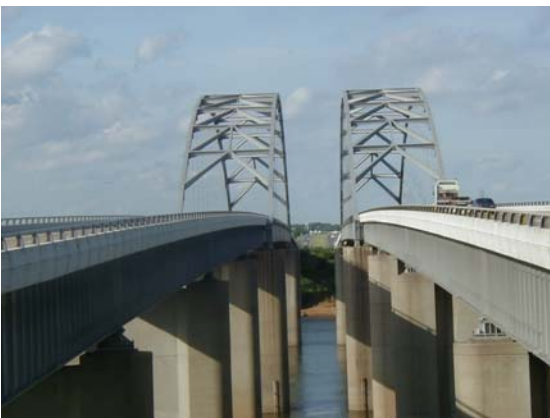
Figure 17
Plate Girder Bridge with Steel Arch (25)

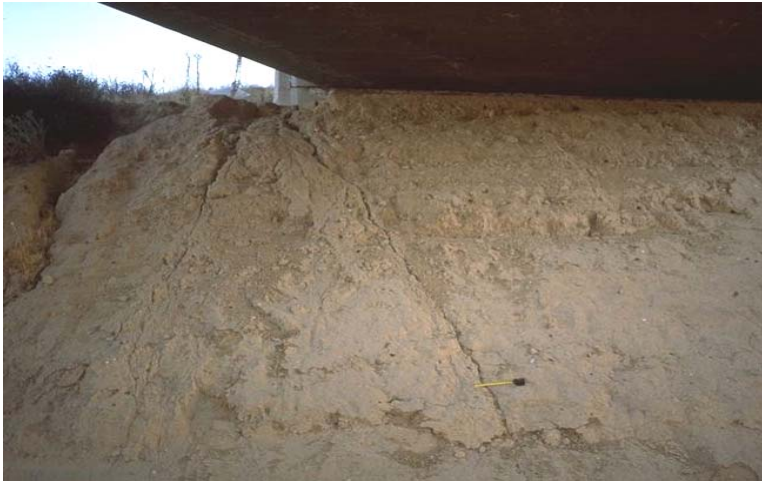
Figure 18 **Minor damage.** Ground crack extending diagonally down slope under the abutment. (1)

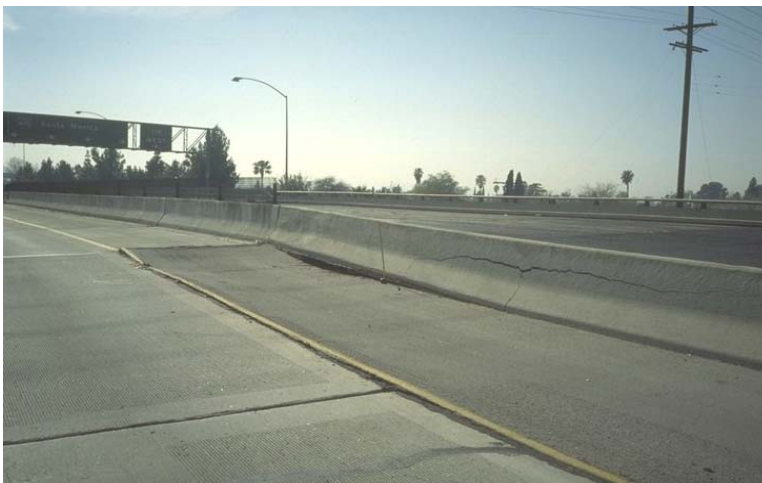
Figure 19 **Minor Damage.** Approach slab settlement at the abutment AC median shoulder. (1)

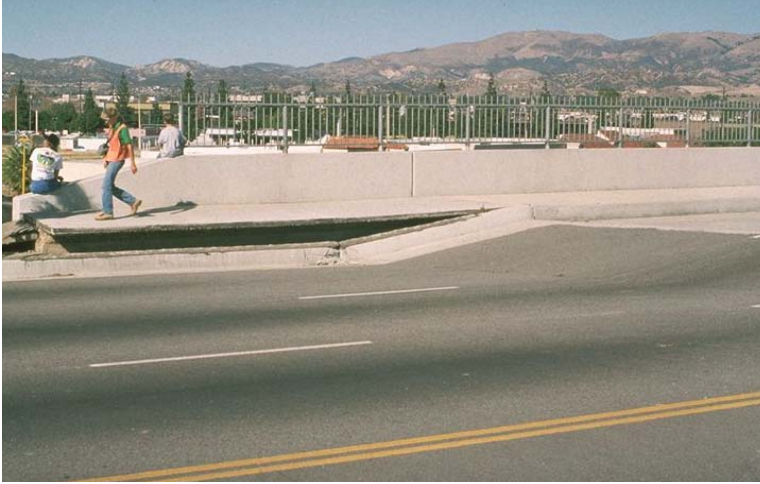
Figure 20 **Moderate Damage.** Settlement of the bridge approach slab. (1)

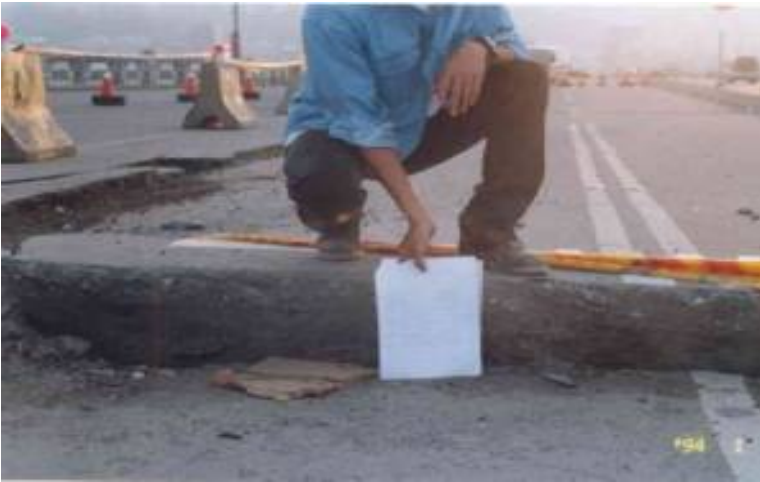
Figure 21 **Moderate Damage.** Approach settlement at the abutment. (2)

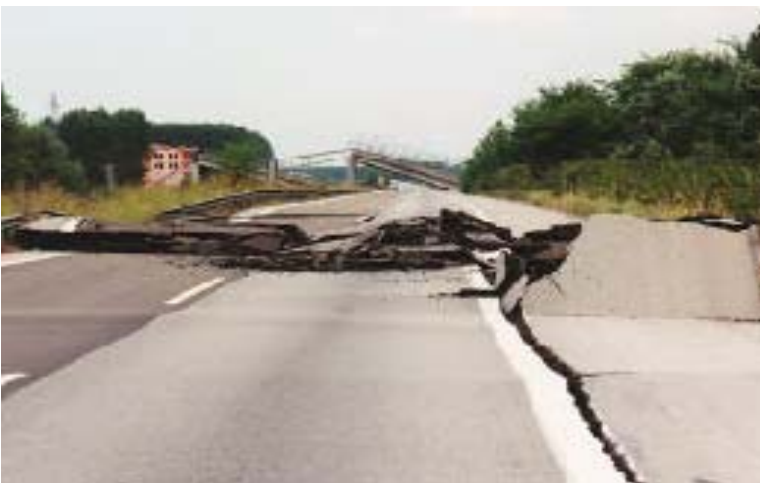
Figure 22 **Severe Damage.** Damage to the roadway due to fault rupture. (3)

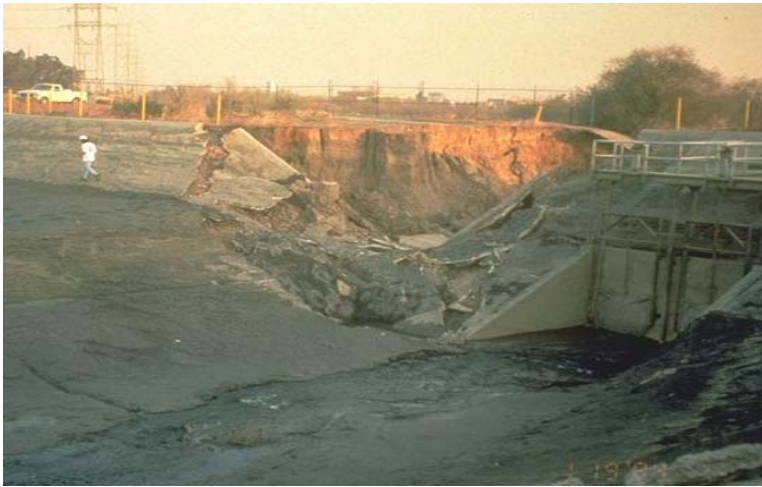
Figure 23 **Total Failure.** Embankment settlement. (1)

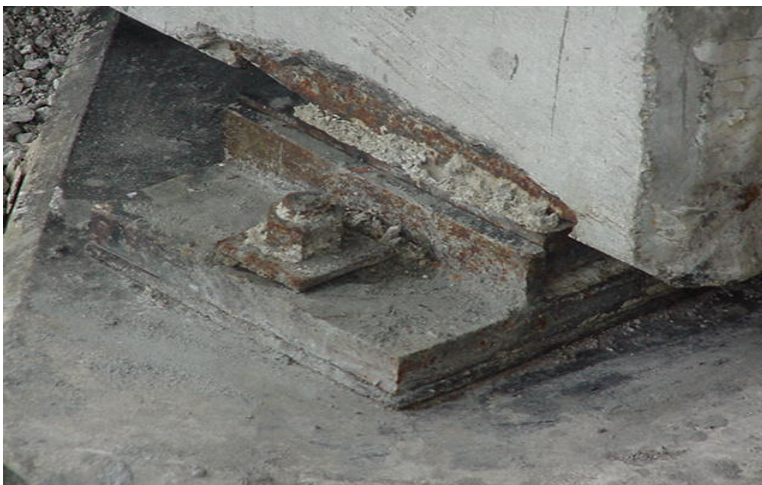
Figure 24 An already corroded “slider” type bearing assembly is susceptible to transverse shearing forces induced by seismic demands and may pose a threat of collapse if the displacements become excessive once sheared. (25)

Concrete spans should be inspected for flexural cracks, shear cracks and spalling at the bearings. Excessive deflection should also be noted, as this would indicate yielded reinforcement or prestressing strands that may not be capable of supporting necessary live loads. In concrete structures it is possible to tap on the section with a hammer and determine its integrity. A resulting high pitch sound indicates that the concrete section is solid, whereas, and a low pitch “thud” indicates the section is cracked. The bearing assemblies should be examined for cracking or spalling concrete. The girders should be inspected for any shifting or misalignment. Typically, precast, prestressed concrete girders are supported on neoprene pads in a formed key or slider type bearings, as shown in Figure 24.

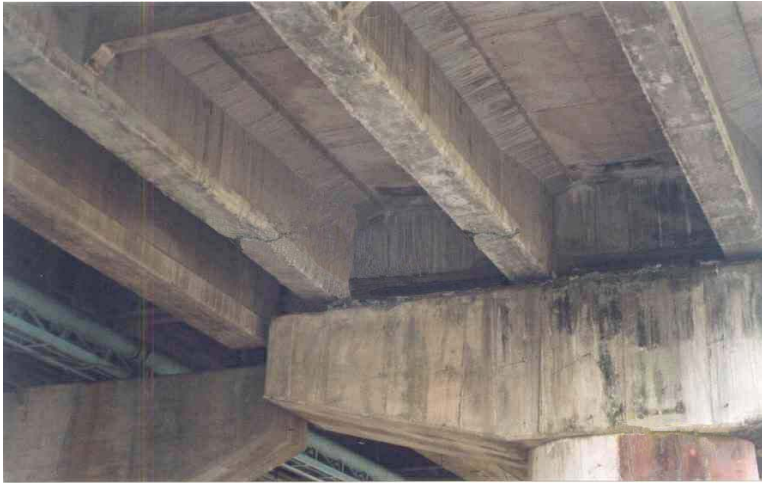
Figure 25 **Minor Damage.** Shear cracks have begun to develop near the supports of the beams. (1) (Photo modified by Tom Sardo to illustrate the increasing level of earthquake damage for illustrative and training purposes).

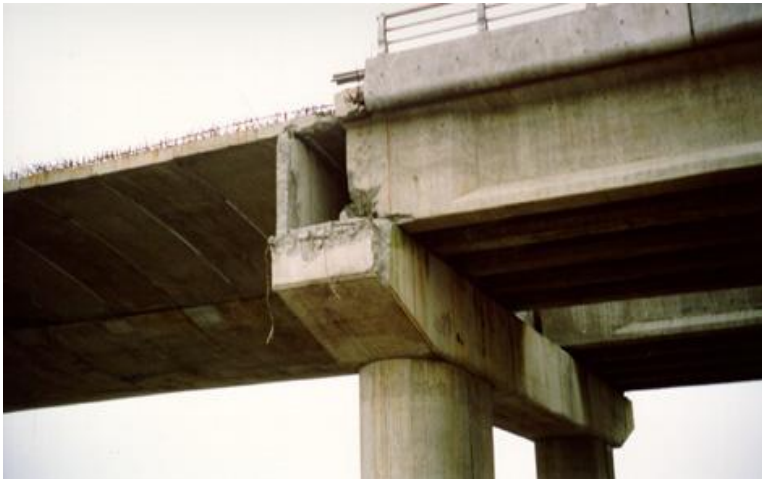
Figure 26 **Moderate Damage.** Cap beam damage. (4)

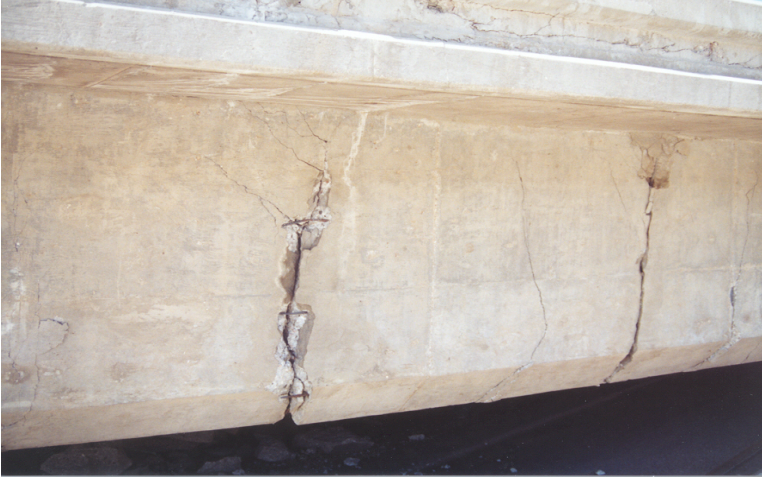
Figure 27 **Moderate Damage.** Flexural cracks in a concrete box girder bridge. (5)

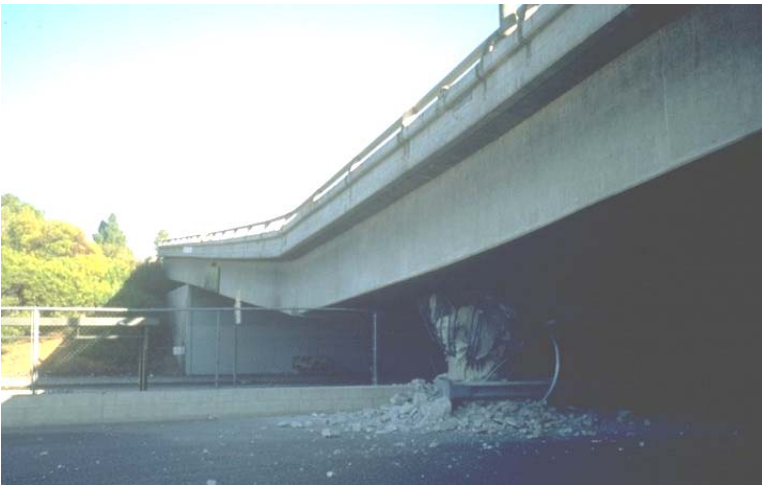
Figure 28 **Severe Damage.** Excessive damage to the superstructure and the substructure has caused partial collapse to the bridge, rendering it unsafe for traffic. (1)

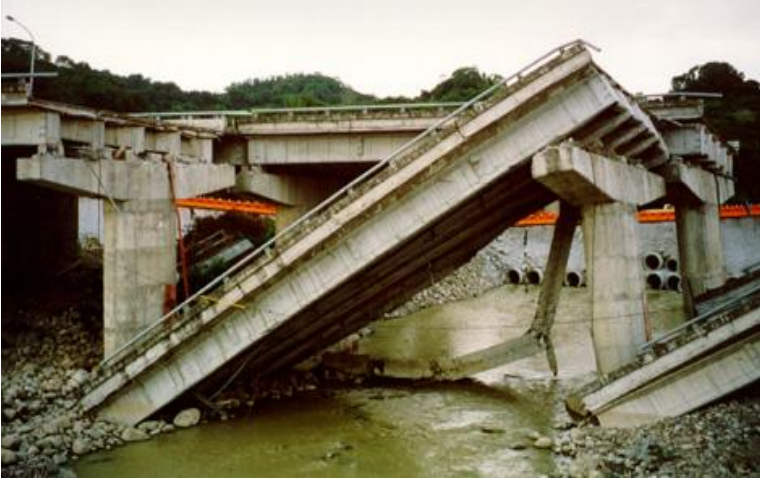
Figure 29 **Total Failure.** Collapse of simply supported precast, prestressed concrete girders. (4)

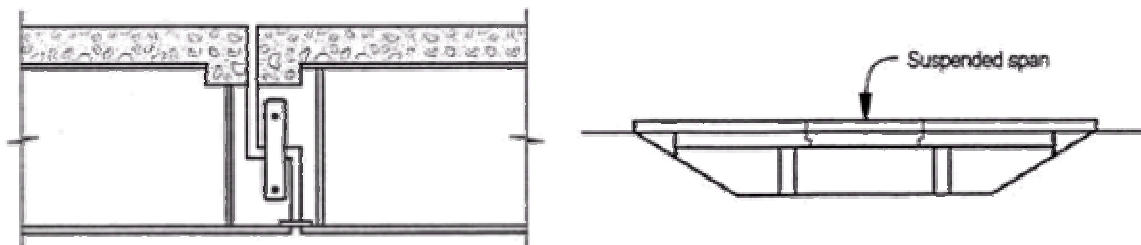
Figure 30 Suspended span detail in a steel girder bridge. (6)

Steel spans require careful inspection since the damage may not be as noticeable as in concrete components. Steel spans must be checked for local buckling of critical elements and damage to the chords or diagonals. All plates, hangers, and assemblies should also be carefully inspected. One may look for chipped paint or exposed primer, often of a different color indicating localized damage to a steel member (see Figures 33 & 34). Anchor bolts, which connect steel components to concrete components, such as a bearing assembly to a concrete pier, should be examined for failure at the concrete interface. All connections should be inspected for cracks in the welds and sheared or elongated bolts. Similar to tapping on concrete with a hammer to note its integrity, one may strike a bolt that has elongated and note the sound. A sharp ring indicates the bolt has not broken and a low pitch sound, or “thud”, indicates a broken bolt. Finally, all bolts should be intact and nuts tight. The girders should be inspected for any misalignment, cracking or cracked welds. Especially crucial are the “hanger pins” used to support suspended spans of a steel girder bridge. This detail is vulnerable to seismic attack and leads to complete loss of span support. See Figure 30.

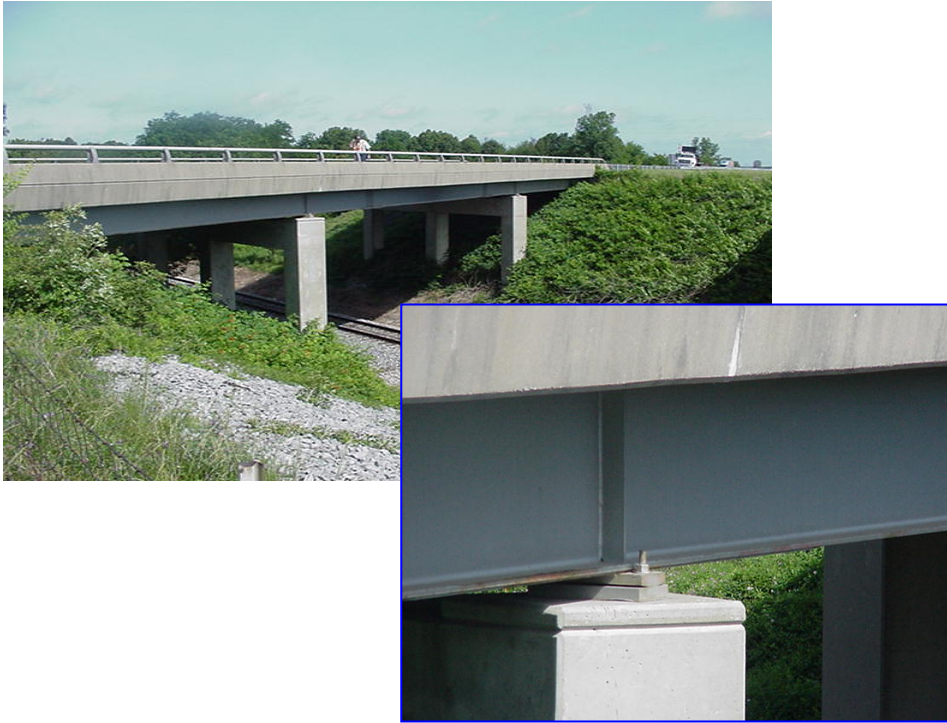
Figure 31 Continuous steel plate girder bridge. (25)

A majority of the steel plate girder bridges in Western Kentucky along Interstate I-24 are multi-span with continuity provided over the supports, as shown in Figure 31, which do not employ the use of “hanger pins”. Because of this continuity, these types of structures provide an added redundancy against seismic attack due to the lack of expansion joints and the possibility of becoming unseated, as would be the case in a simply supported span.

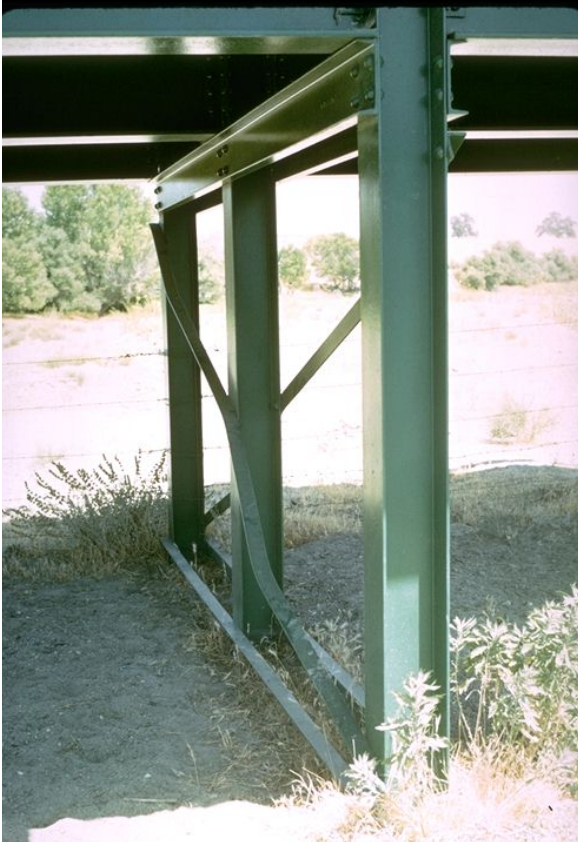
Figure 32 **Minor Damage.** Buckled cross-bracing. (1)

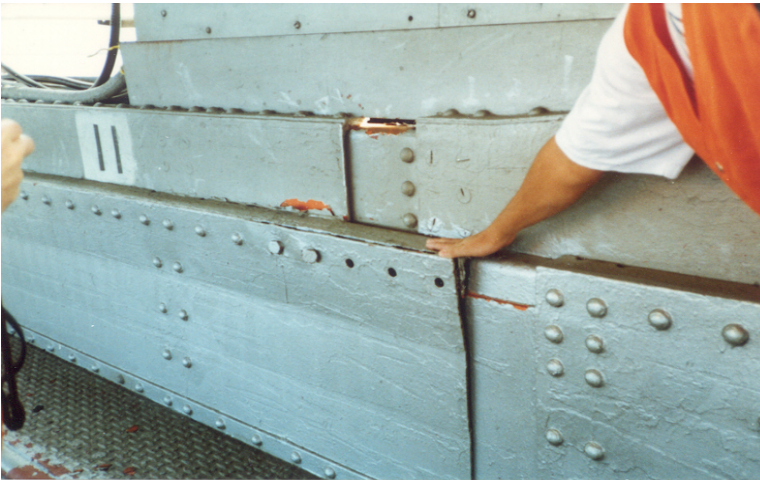
Figure 33 **Minor Damage.** Sheared rivets at the steel truss plate. (9)

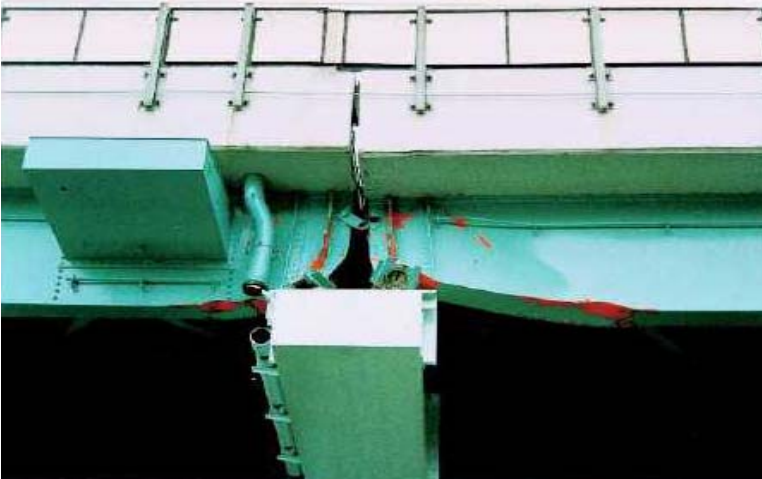
Figure 34 **Moderate Damage.** Buckled flanges and webs of the steel girders and bearing failure. (10)

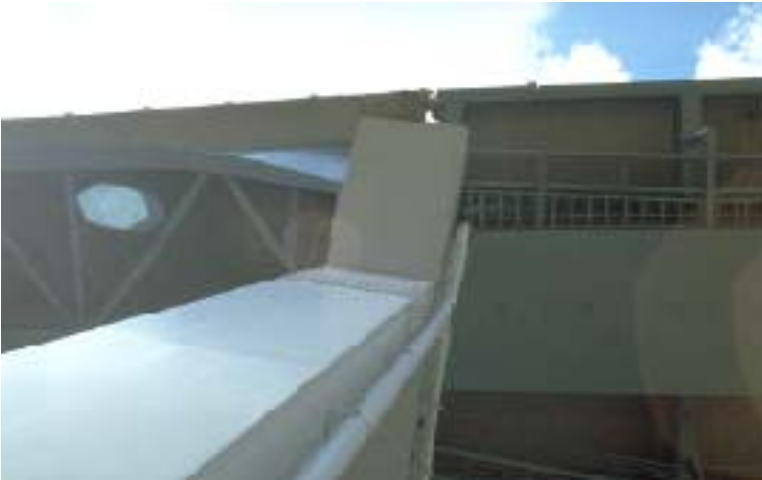
Figure 35 **Severe Damage.** Buckling of the steel girders. (1)

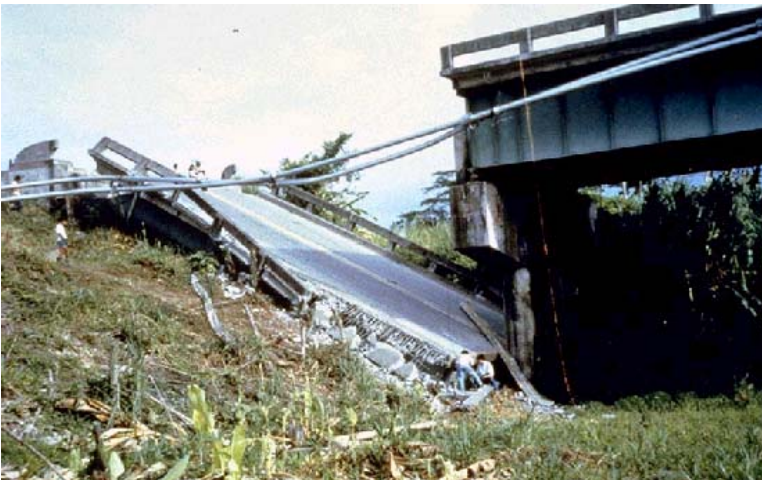
Figure 36 **Total Failure.** Collapse of the simply supported span due to anchor bolt failure and spalling of the concrete cover. (11)

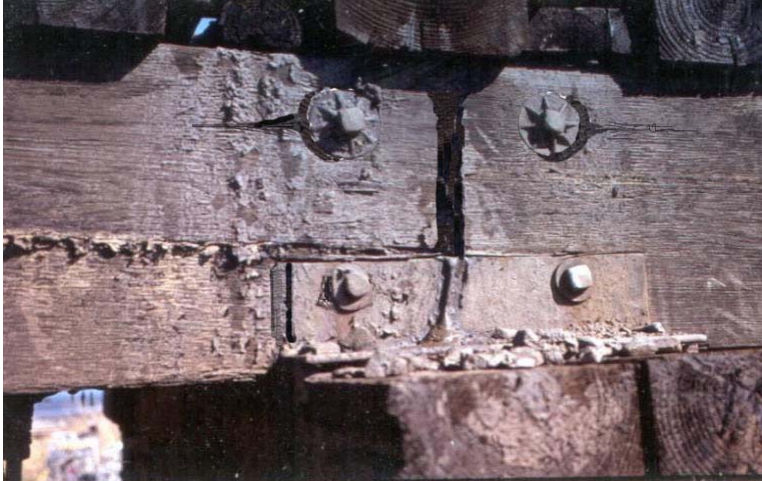
Figure 37 **Minor Damage.** Timber connection pulled apart from earthquake. Note the cracking near the support. This could be caused from shrinkage since it is perpendicular to the grain, however, since the bottom plate shows signs of displacement, it would indicate earthquake related damage. (29) (Photo modified by Tom Sardo to illustrate the increasing level of earthquake damage for illustrative and training purposes).

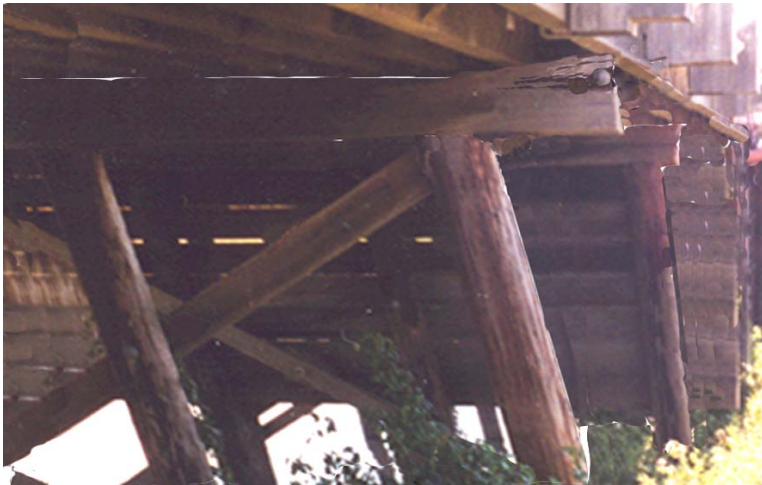
Figure 38 **Moderate Damage.** Lateral instability failure. The earthquake has caused the bridge to displace excessively in the longitudinal direction. The connection has failed and pulled away from the diagonal in the upper right of the photo. The top cap is still supported by the columns but in a very unstable configuration. (10) (Photo modified by Tom Sardo to illustrate the increasing level of earthquake damage for illustrative and training purposes).

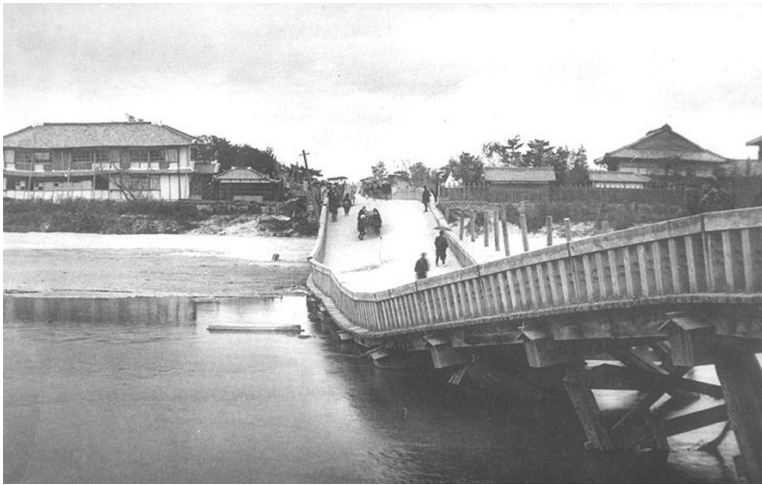
Figure 39 **Severe Damage.** Lateral instability failure. The earthquake has caused the bridge to further displace to the left side of the photo, rendering it unsafe for traffic. (1) (Photo modified by Tom Sardo to illustrate the increasing level of earthquake damage for illustrative and training purposes).

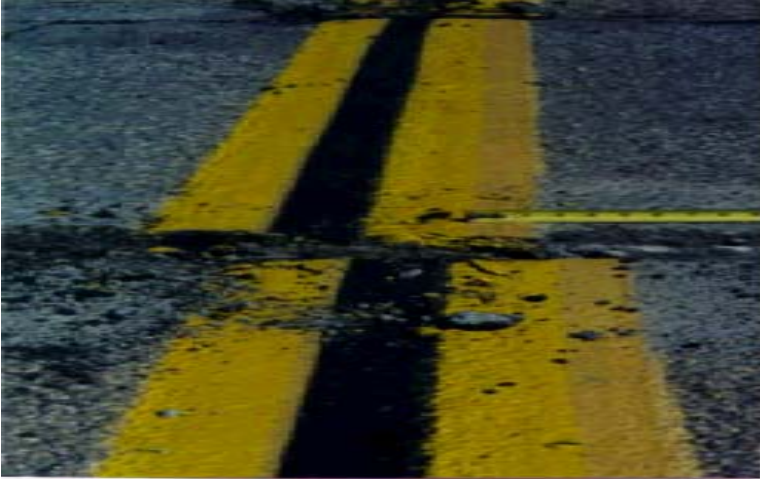
Figure 40 **Minor Damage.** Three inches of transverse movement along the centerline. (8)

The deck of a bridge structure often reveals valuable information as to whether the structure has experienced sufficient forces or movement to cause significant damage. Major deck spalling, displacements at the expansion joints and excessive deflections within spans often indicate internal damage. Displacement of the longitudinal joints indicates displacements likely experienced at the top of columns. Bridges built on high skews will experience lateral movement perpendicular to the span and cause spalling of the barrier rail, curb, and damage to the guard rail. Generally, this type of damage does not represent a structural problem itself but may jeopardize the safety of the traveling public. Barrier rails can often be inspected for fresh scratches on scribe scripts or gaps in the rails to determine the magnitudes of recent movement.

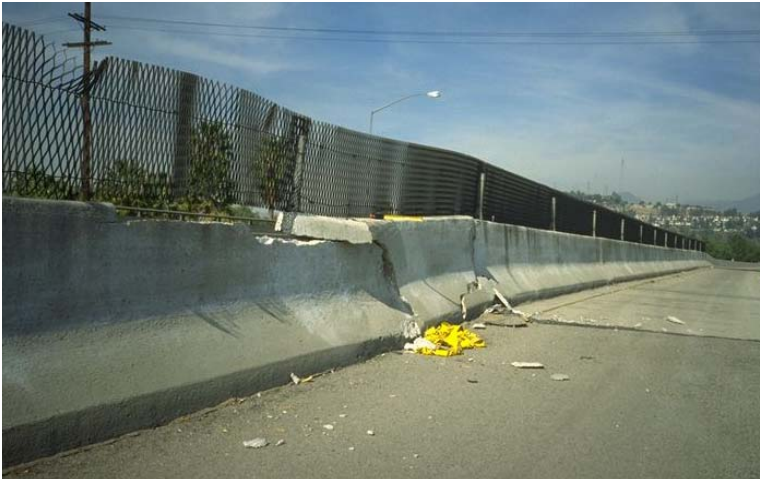
Figure 41 **Minor Damage.** Barrier rail crushing. (1)

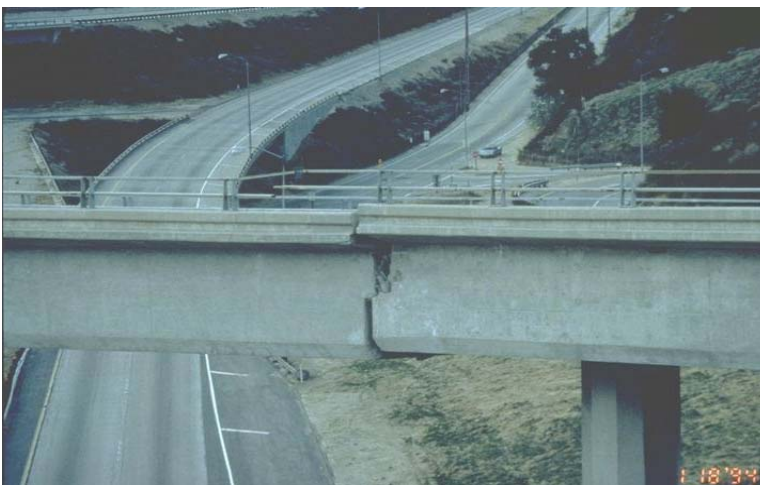
Figure 42 **Moderate Damage.** Failed bearing pads and crushing at the hinge joint. Note the short seat length supporting the superstructure. (1)

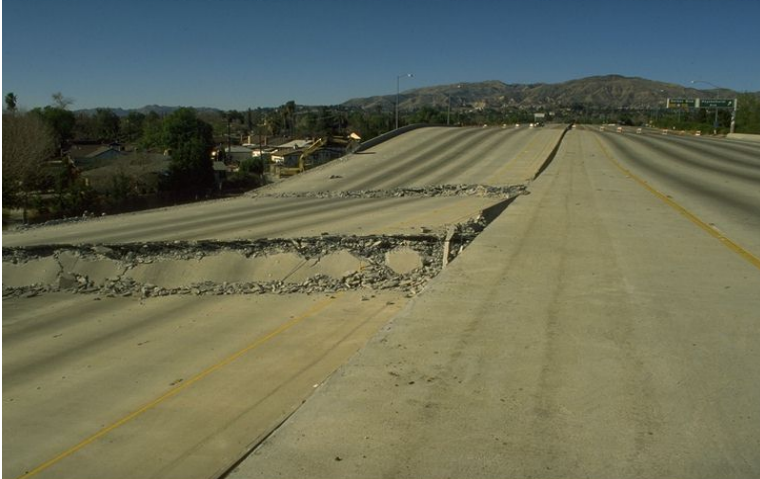
Figure 43 **Severe Damage.** Deck cracking. (1)

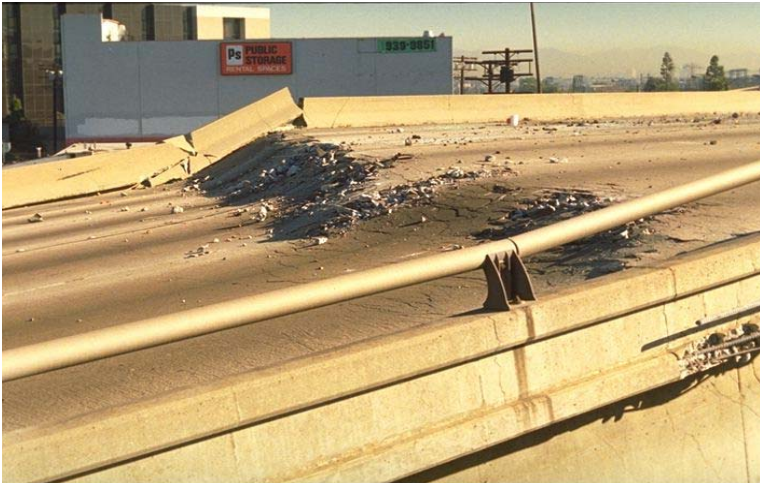
Figure 44 **Severe Damage.** Overview of the shear failure in the deck. (1)

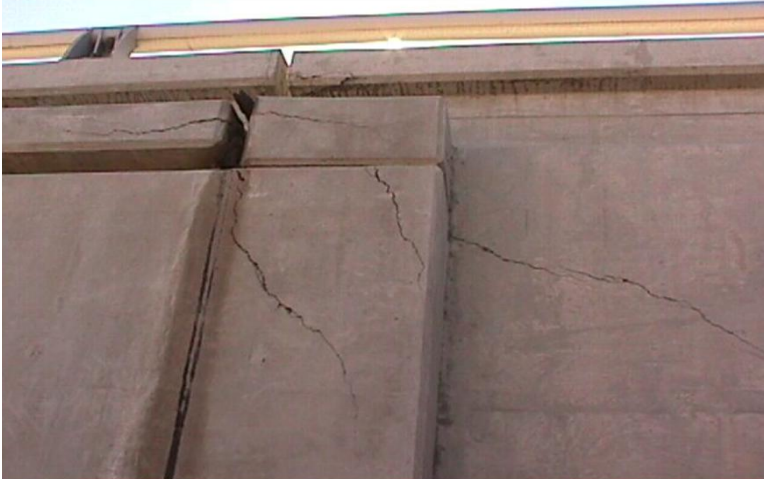
Figure 45 **Minor Damage.** Shear cracking at the abutment backwall and wingwall. (10)

Longitudinal movement during an earthquake may damage the abutment backwall. More often than not, this type of failure is desirable, since the backwall will behave like a “fuse” and protect the supporting piles from seismic damage. However, excessive longitudinal movement is still undesirable, since this would require much larger support widths. Transverse movement may displace or crack the wingwalls, as well as, the abutment shear keys. The backwall and wingwalls may also suffer flexural or shear cracks. Loose or settled fill, slope failures, liquefaction, fissures and differential settlements at the base of the abutments may be observed as evidence of foundation movement and possible damage.

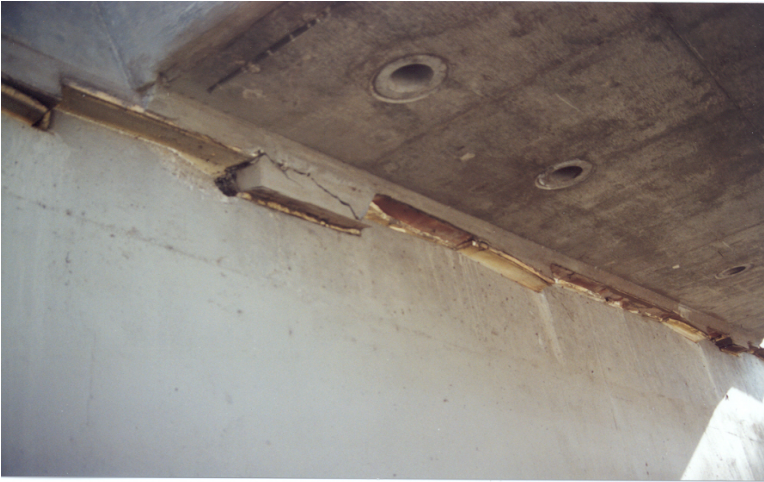
Figure 46 **Minor Damage.** Intermediate shear key damage and longitudinal offset at the abutment. (5)

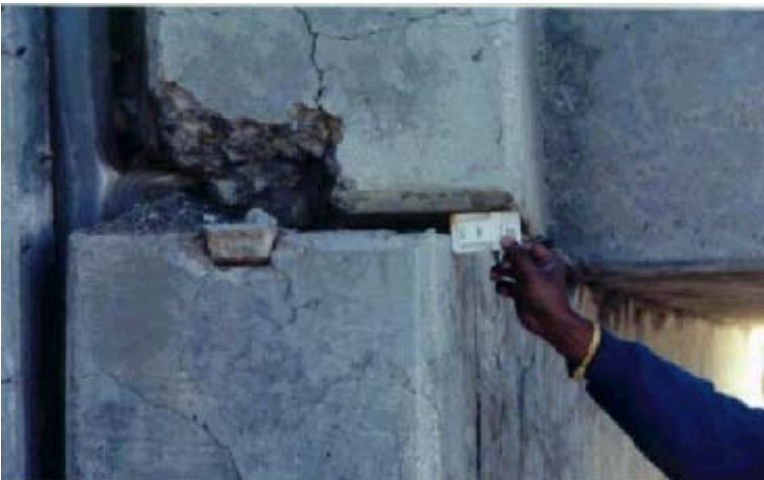
Figure 47 **Moderate Damage.** Longitudinal displacement at the abutment seat. (8)

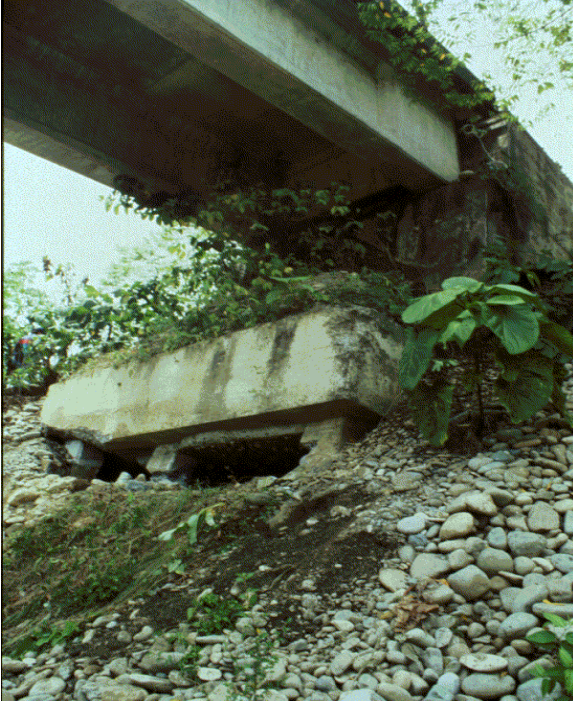
Figure 48 **Severe Damage.** Foundation movement. Longitudinal displacement and rotation of the abutment footing. Notice the flexure and shear failure of the exposed piles. (10)

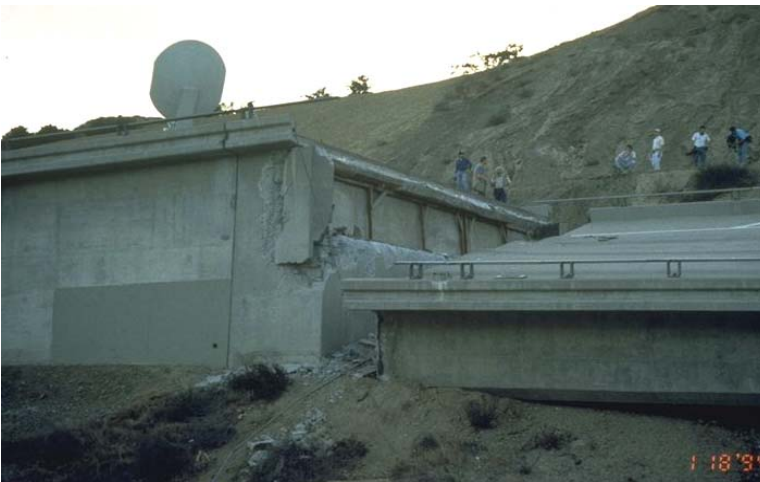
Figure 49 **Total Failure.** The shear key failed and the span unseated at the abutment. (1)

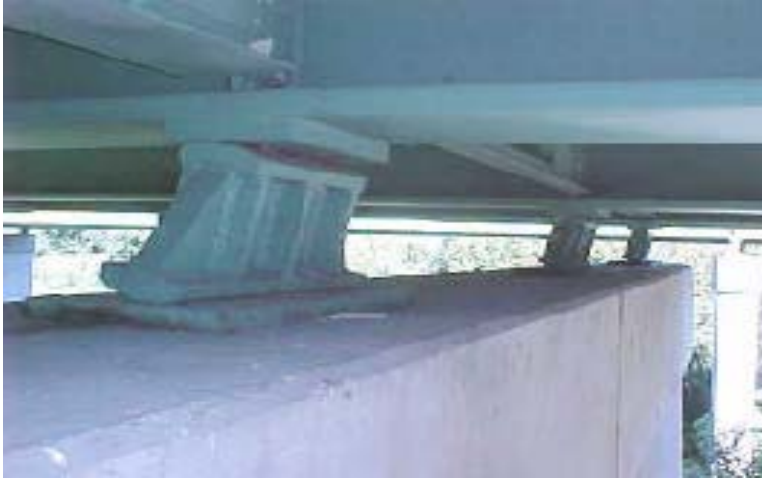
Figure 50 **No Damage.** Movement of the rocker bearing due to thermal loads. (13)

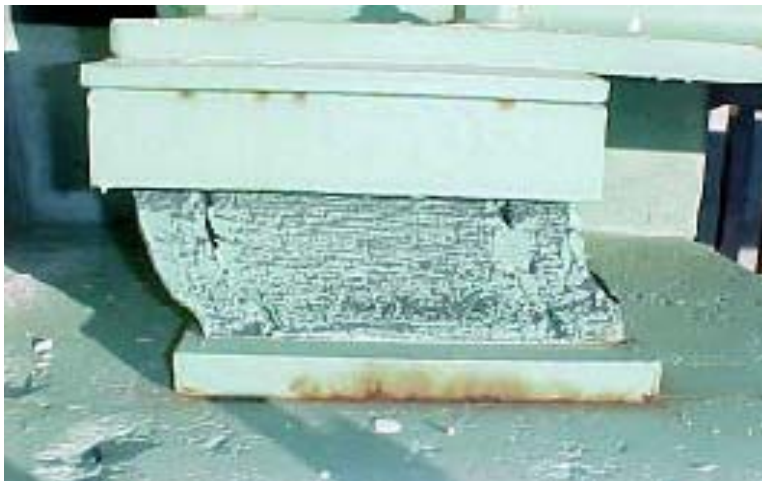
Figure 51 **No Damage.** Movement of the elastomeric bearing under thermal loads. (13)

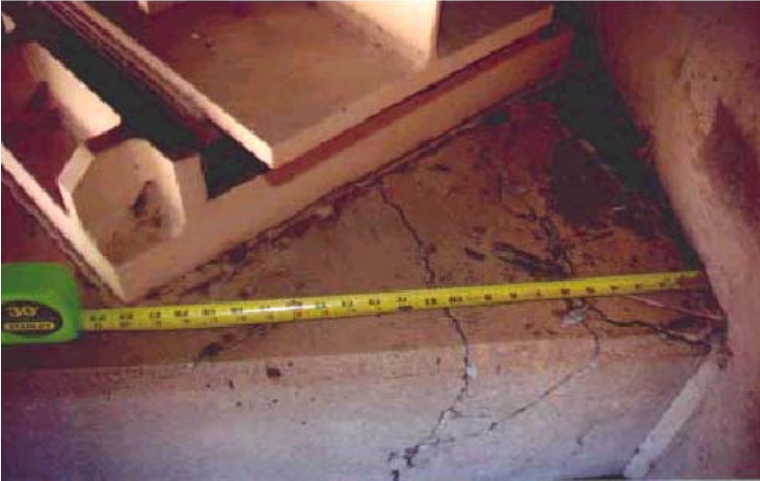
Figure 52 **Minor Damage.** Steel bearing induced cracks. (8)

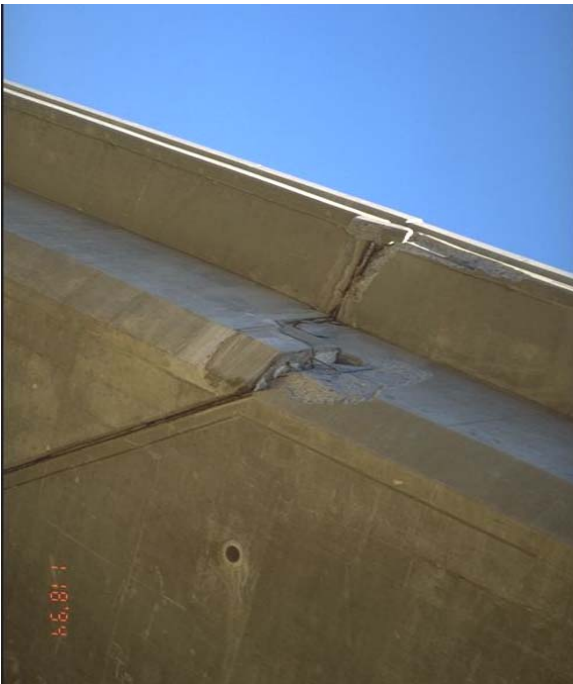
Figure 53 **Minor Damage.** Pounding at the midspan hinge. No superstructure unseating. (1)

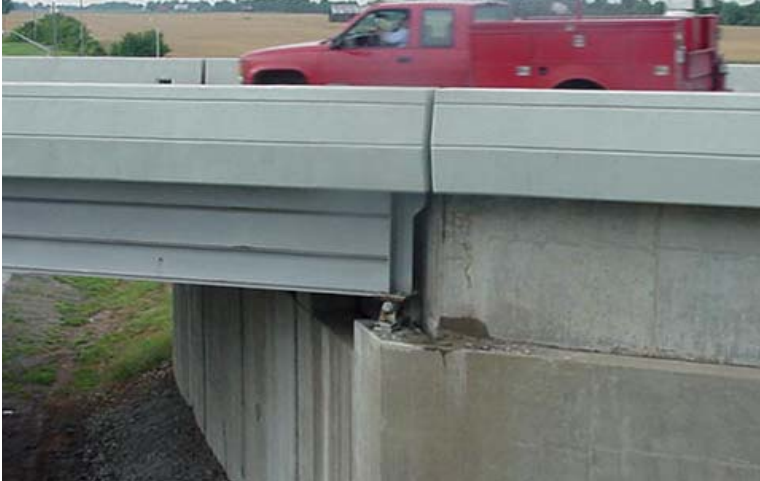
Figure 54 Tall rocker bearings (> 6 inches) on short seats are especially vulnerable to collapse. Generally, if the bearing topples and stays seated, the resulting height of the vertical drop will render the bridge useless. (25)

support. In that way, un-reinforced concrete will not be supporting un-reinforced concrete and result in a confinement failure. Tall rockers are subject to large vertical drops. A vertical drop of 6 inches to 12 inches should be considered as moderate damage. While, a vertical drop of more than 12 inches should be considered severe damage.
